Beaver River Watershed Assessment

Beaver River Watershed Assessment Report – FINAL

Town of Richmond, Rhode Island

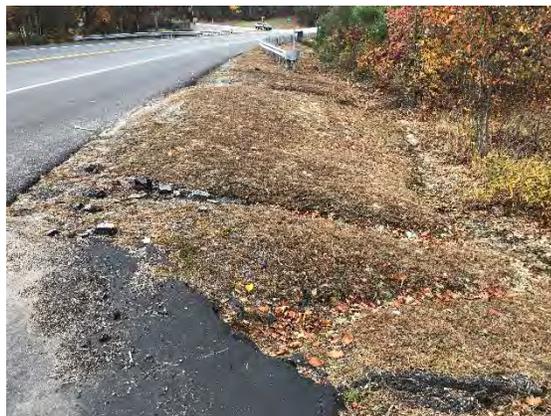
However, stormwater is likely a contributor to a recent (new in 2016) recreation impairment documented in Rhode Island’s Impaired Waters List (March 2018) for Enterococcus. RIDEM, as well as URI Watershed Watch, has done limited water quality monitoring in recent years (2011, 2015-2017) at the Rte 138 bridge where Enterococcus was present above thresholds for recreational uses. More sampling should be done to here to identify estimated stormwater contributions vs. potential wastewater sources. While there are no direct stormwater outfalls in this location, highway runoff concentrates along the shoulders and has created erosion gullies down to the river.

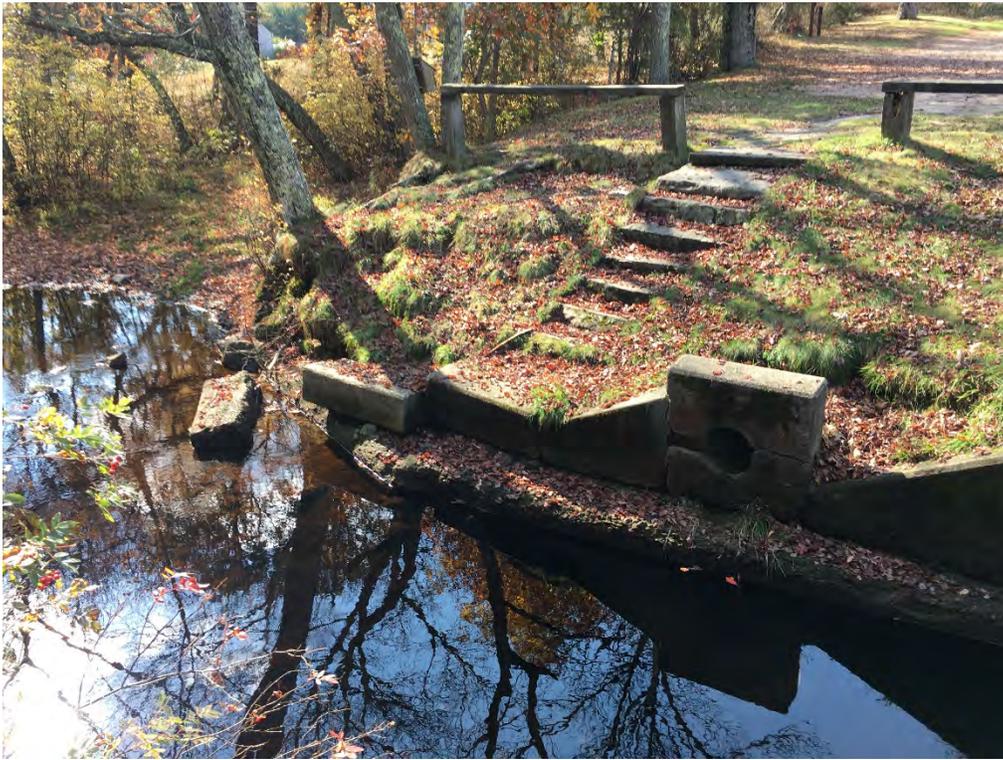
Beaver River Fishing Access (RIDEM)

Opportunities for stormwater management, erosion control, bank restoration and buffer enhancement were observed along this section of Beaver River where fishing activities and access to the river have resulted in complete removal of shrubs and trees. Sedimentation from the unpaved parking lot has migrated along the banks and into the river. This location is a great opportunity to work with RIDEM to address these issues as well as provide public education about the importance of Beaver River and its watershed.

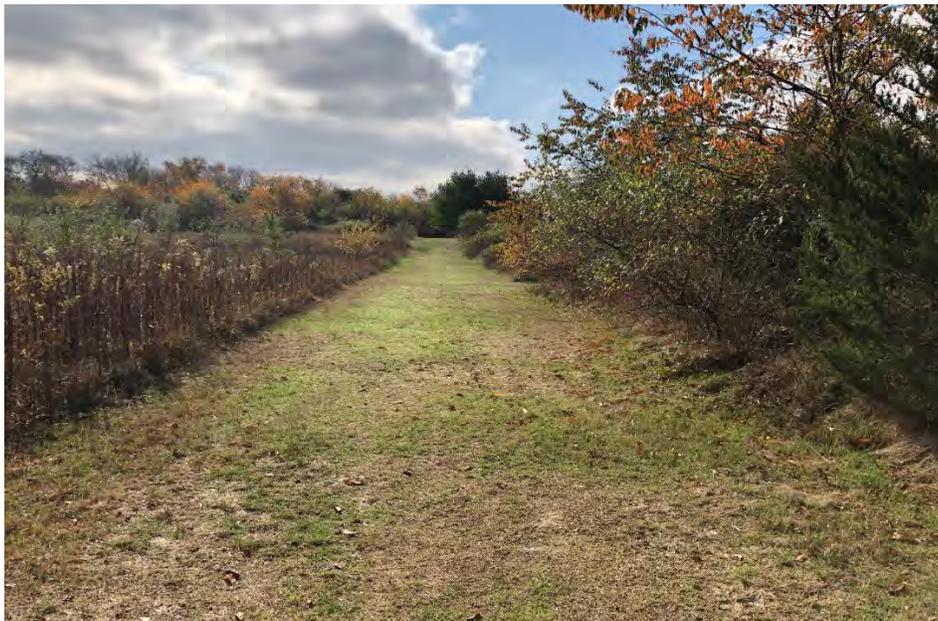
Located east of Beaver River Road between the intersections of Anthony Drive and Rocky Way, the Beaver River Park & Playground has wide open trails with points of interest overlooking the Beaver River and its associated wetland communities. Unfortunately, the trail edges have become overgrown with non-native invasive species such as autumn olive (*Elaeagnus umbellata*) and multiflora rose (*Rosa multiflora*) with dense entanglements of Asiatic bittersweet (*Celastrus orbiculatus*), as well as lesser amounts of shrub honeysuckle (*Lonicera* sp.) and European buckthorn (*Frangula alnus*) which have begun to colonize along interior trails traversing wetland areas. The proximity of non-native fruit-bearing shrubs to the river creates the potential for downstream spread of invasives to otherwise pristine freshwater wetland communities. The centrally located fields have become overgrown with invasive shrubs and weedy herbaceous vegetation. In addition, direct access to the river is open and nearly devoid of woody vegetation and subject to erosion and further spread of invasive species downstream.

Opportunities to restore wetland buffers, improve habitat for local wildlife, and public education regarding invasive species are numerous at this location. The wide trails allow for easy access to problem areas. These efforts would be intensive and on-going for many years. It may be productive to first manage a test plot, removing non-native species and revegetating with native species to help refine the long-term management plan.

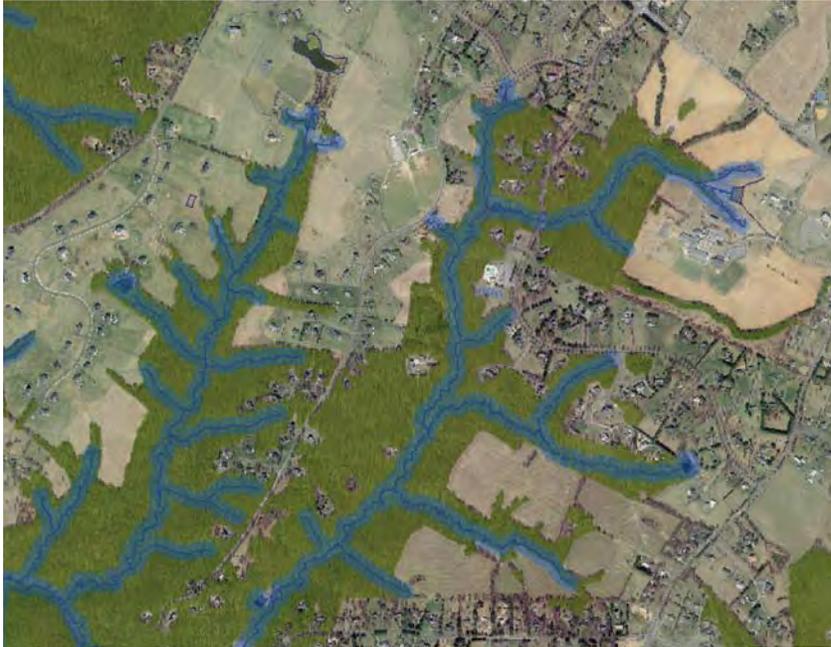
The green area in the figure represents the vegetated riparian buffer and the shaded blue area indicates a buffer zone of 100 feet on either side of the stream. (HW graphic)

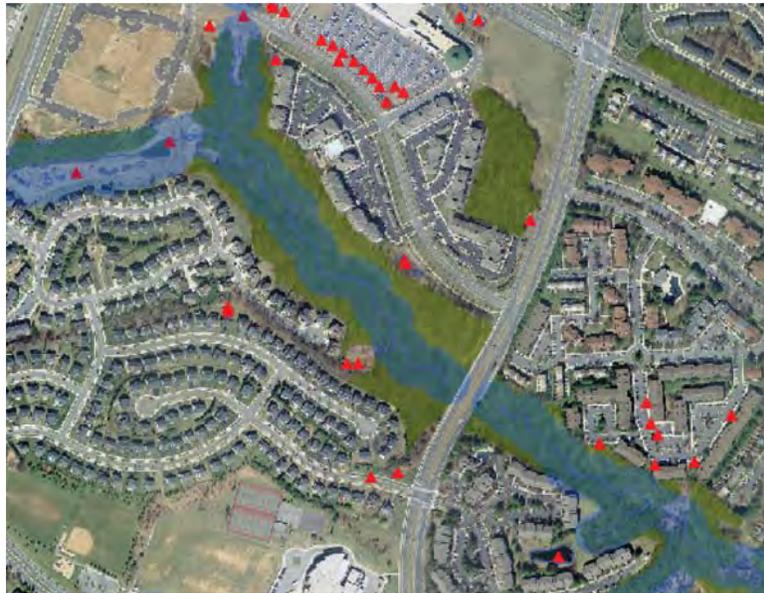
Figure 3-5 Locations of Stormwater BMPs Relative to Stream Buffers.

The red triangles in the graphic below represent the location of stormwater BMPs. Some of these have been effectively implemented in the very outer edge of the vegetated buffer (green area) along the riparian corridor in Montgomery County, MD. The shaded blue area indicates a buffer zone of 100 feet on either side of the stream as a reference.

The red triangles represent stormwater BMPs; the green area represents the vegetated riparian buffer; and the shaded blue area indicates a buffer zone of 100 feet on either side of the stream as a reference. (HW graphic)

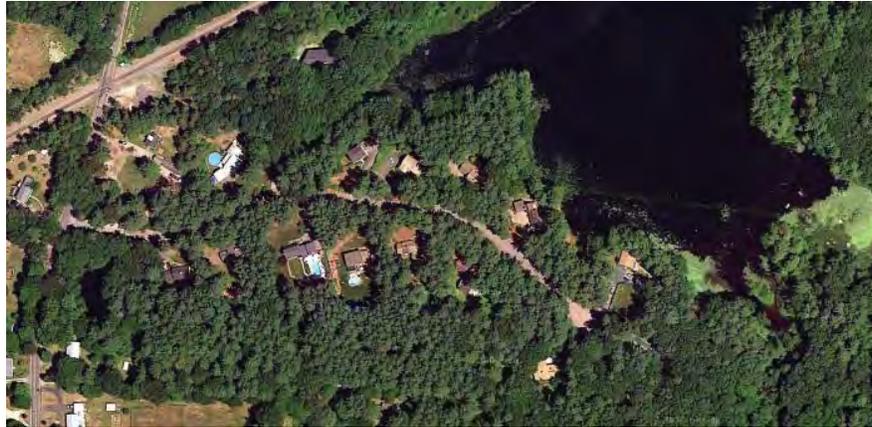
Uniform requirements for lot size and setbacks cause subdivisions like the one in this aerial photo to consume far more land than necessary. This subdivision has encroached into wetland and pond buffer areas causing visible signs of eutrophication as indicated by the light green algal bloom. (Google Maps)

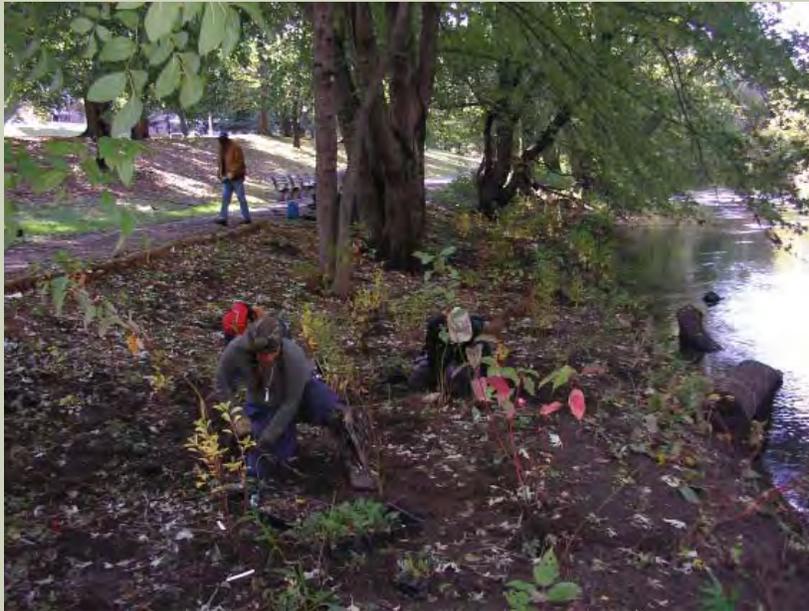
Figure 3-8 Buffer Zone Planting.

Careful placement and installation of native vegetation is required for restoring buffer areas that were cleared. (HW photo)

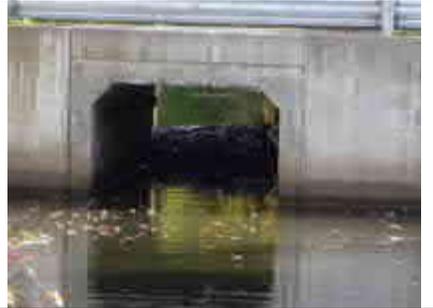
Reach	Town	Bridge/ Culvert Code	Location Lat.	RCPA Long.	Priority	Description	Photograph
CHIP-8	Exeter, RI	4455	41.518	-71.526	High	Significantly undersized, beaver occupied

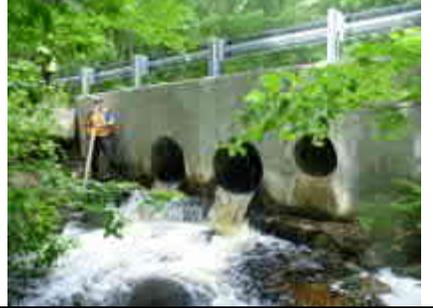
BER-7	Richmond, RI	2967	41.526	-71.639	High	Undersized, perched at outlet, culvert was overtopped in 2010

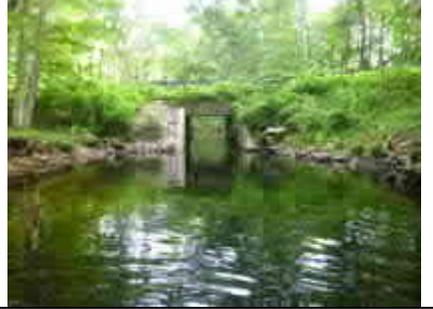
GAS-8	North Stonington, CT	347	41.472	-71.816	Low	Undersized, side channels and aggradation upstream, large scour pool downstream

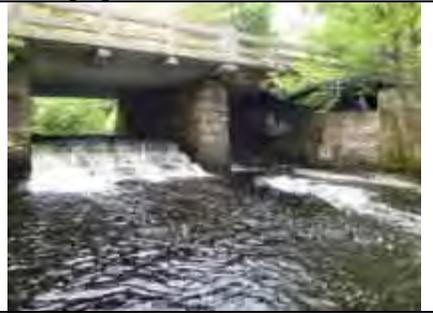
GAS-2	Hopkinton, RI		41.431	-71.790	High	Dam not in use, partially broken down, blocking fish passage to high quality habitat

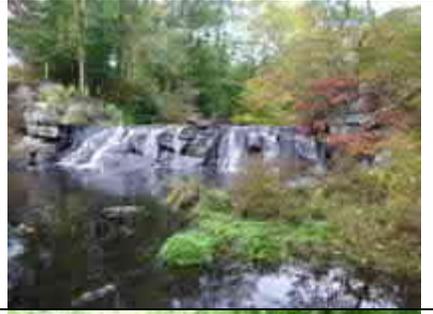
BER-6b	Richmond, RI		41.521	-71.640	High	Pond not in use but backs water up to road, potentially high quality habitat with connectivity

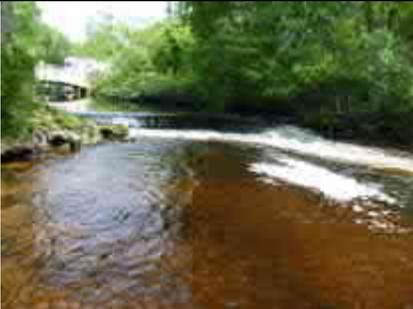
Reach	Town	Bridge/ Culvert Code	Location Lat.	RCPA Long.	Priority	Description	Photograph
PAR-18	Charlestown, RI		41.443	-71.681	Low	Only dam/weir without some sort of fish ladder on mainstem, gage could function without weir

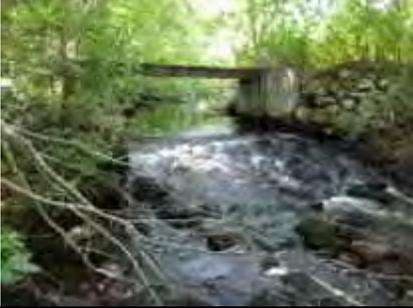
BER-4	Richmond, RI		41.498	-71.631	Low	Splits up good habitat, not in use, contributed to trail washout

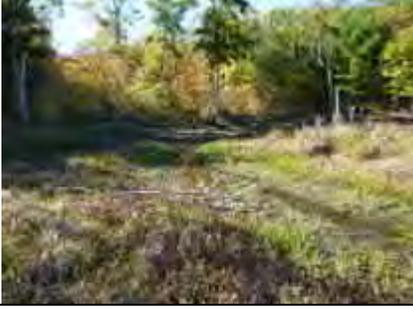
MEB-7	Richmond, RI		41.488	-71.676	Low	Will turn wetlands back into a floodplain forest

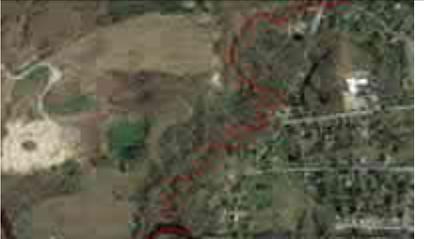
Reach	Town	Bridge/ Culvert Code	Location		RCPA	Priority	Description	Photograph
			Lat.	Long.				
Corridor protection								
GAS-1	Hopkinton, RI		41.418	-71.797		High	Entire reach should be protected, very dynamic, great habitat, poor location for development, luckily development has not encroached significantly

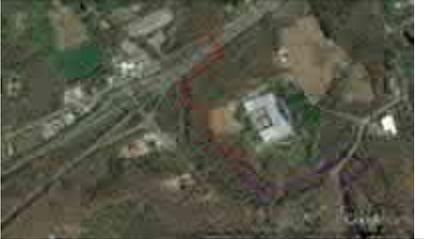
GAS-4	Hopkinton, RI		41.441	-71.797		High	Dynamic channel, recent avulsion, good habitat

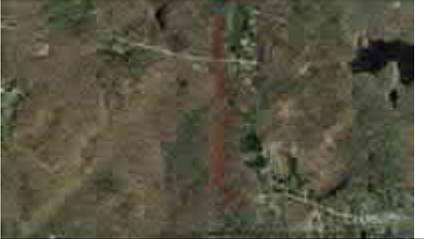
GAS-8	North Stonington, CT		41.471	-71.817		High	Archaeological sites, good habitat potential, little modern encroachment

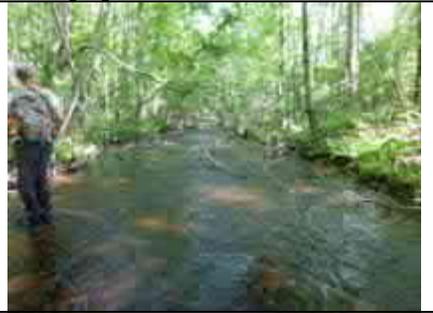
Reach	Town	Bridge/ Culvert Code	Location Lat.	RCPA Long.	Priority	Description	Photograph
BER-6-7	Richmond, RI		41.521	-71.640	High	Wood additions to create habitat complexity and increase use of side channels

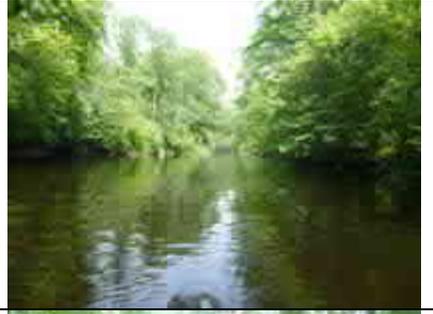
PAR-18	Charlestown, RI		41.443	-71.681	High	Log jams could be used to help reform meanders

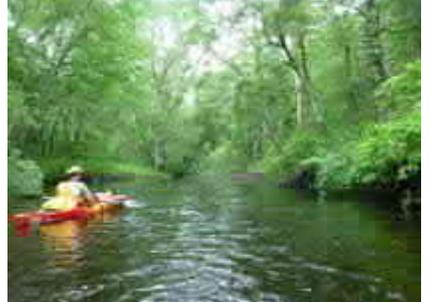
WOD-14-16	Exeter, RI		41.560	-71.714	Low	Improve already good habitat with additional wood to create log jams

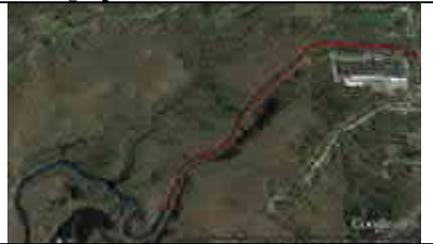
BER-2	Richmond, RI		41.478	-71.624	Low	Pond takes lots of water out of stream, potential avulsion risk

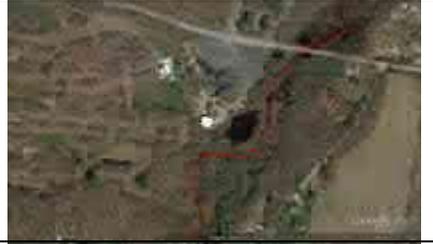
CHIP-8	Exeter, RI		41.517	-71.526	Low	Pond/berm that could be breached to increase floodplain access

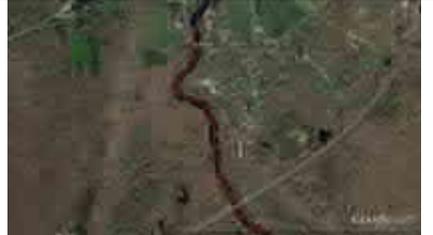
PAR-15	Charlestown, RI		41.411	-71.726	Low	Artificial floodplain constriction that could be alleviated with flood relief culverts, development present upstream
